Manhole Inspection Summary

Manhole # **S31C__014MH**

Location Address: **404 DIAMOND ST** Cross Street: **MULBERRY ST**

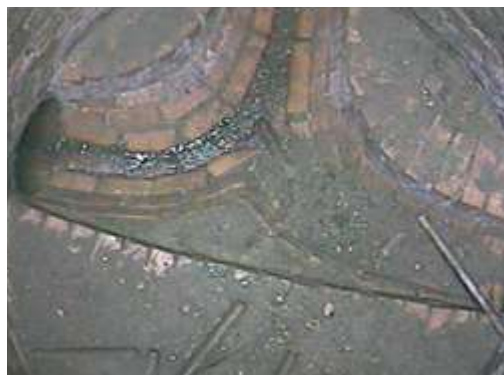
Top View

Cover Shape: **Circular** Diameter: **25.** (in.) Length: (in.) Dist A/B Grade: **0** (in.)
75

Type: **Sanitary** Condition: **Sound** Cover Material: **Cast Iron**

Chimney / Frame Adjustment ☒ Exists Material: **Brick** ☐ Parged Height: **6** (in.)

Condition: ☒ Sound ☐ Cracked ☐ Root Intrusion ☐ Loose Brick ☐ Deteriorated

Barrel Material: **Brick** ☐ Parged

Bench ☒ Exists Material: **Brick** ☐ Parged

Condition: ☒ Sound ☐ Cracked ☐ Root Intrusion ☐ Deteriorated ☐ Leaks ☐ Debris

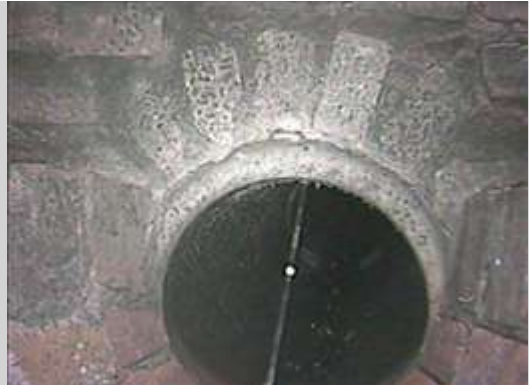
12 O'Clock Outflow

10 in. Circular Gravity Sewer
Pipe Out @ 12 O'Clock

Pipe Height: **4.8** (in.) Rod and Bar
Pipe Material: **Clay** ☐ Pipe Lined
Invert Depth: **10.03** (ft.) Flow Characteristics: **Slow**
Deposits: ☒ None ☐ Mud ☐ Sludge ☐ Debris ☐ Grease
Silt Depth: (in.) Deposits Extent:
Infiltration: **None** Pipe Seal Cond: **Sound**

Drop: **None**

Connects To: **Manhole**

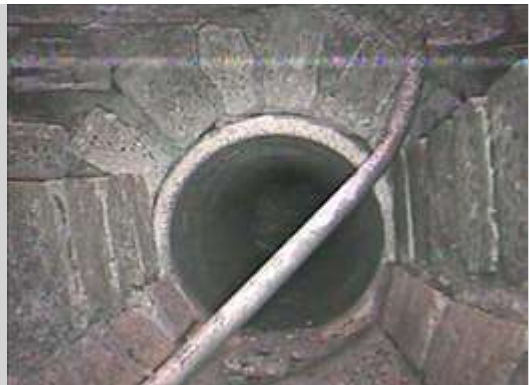
3 O'Clock Inflow

8 in. Circular Gravity Sewer
Pipe In @ 3 O'Clock

Pipe Height: **4.8** (in.) Rod and Bar
Pipe Material: **Clay** ☐ Pipe Lined
Invert Depth: **9.65** (ft.) Flow Characteristics: **Slow**
Deposits: ☒ None ☐ Mud ☐ Sludge ☐ Debris ☐ Grease
Silt Depth: (in.) Deposits Extent:
Infiltration: **None** Pipe Seal Cond: **Sound**

Drop: **None**

Connects To: **Dead End**

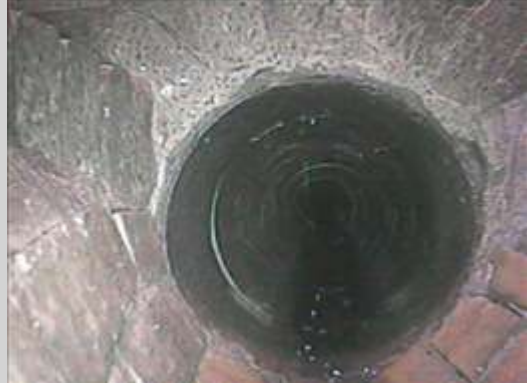
9 O'Clock Inflow

10 in. Circular Gravity Sewer
Pipe In @ 9 O'Clock

Pipe Material: **Clay** ☐ Pipe Lined

Invert Depth: **9.80** (ft.) Flow Characteristics: **Slow**

Infiltration: **None** Pipe Seal Cond: **Sound**

Drop: **None**

Connects To: **Manhole**
